**DEPARTMENT OF TRANSPORTATION**

Contract #: 04-0120F4Cty: SF/ALA Rte: 80 PM: 13.2/13.9File #: 69.28**WELDING INSPECTION REPORT****Resident Engineer:** Siegenthaler, Peter**Address:** 333 Burma Road**City:** Oakland, CA 94607**Report No:** WIR-021501**Date Inspected:** 07-Mar-2011**Project Name:** SAS Superstructure**OSM Arrival Time:** 700**Prime Contractor:** American Bridge/Fluor Enterprises, a JV**OSM Departure Time:** 1900**Contractor:** Zhenhua Port Machinery Company, Ltd (ZPMC), Changxing Island **Location:** Shanghai, China**CWI Name:** Li Yang and Zhu Zhong Hai**CWI Present:** Yes No**Inspected CWI report:** Yes No N/A**Rod Oven in Use:** Yes No N/A**Electrode to specification:** Yes No N/A**Weld Procedures Followed:** Yes No N/A**Qualified Welders:** Yes No N/A**Verified Joint Fit-up:** Yes No N/A**Approved Drawings:** Yes No N/A**Approved WPS:** Yes No N/A**Delayed / Cancelled:** Yes No N/A**Bridge No:** 34-0006**Component:** OBG Trial Assembly**Summary of Items Observed:**

## WELDING INSPECTION REPORT

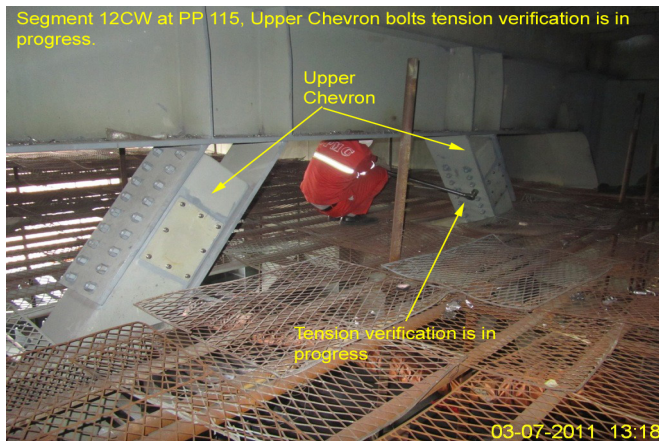
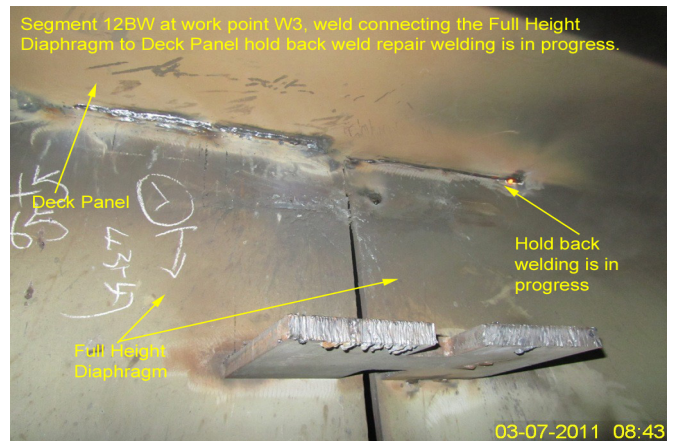
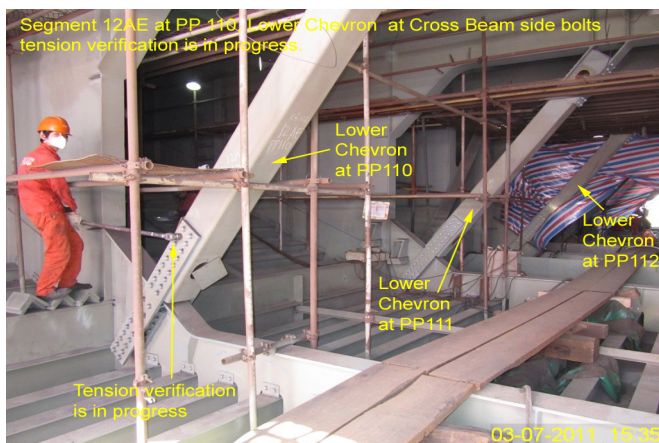
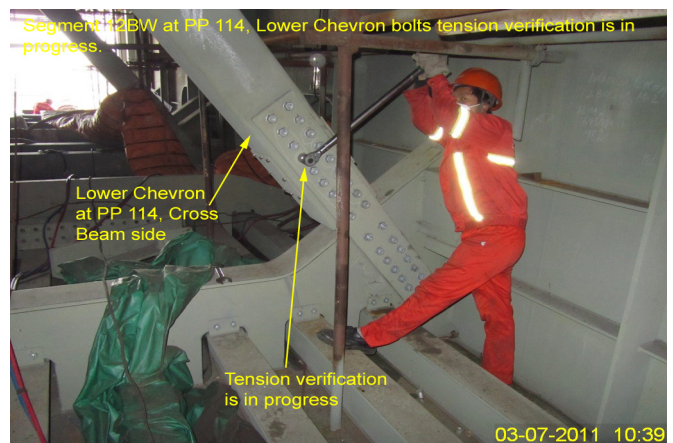
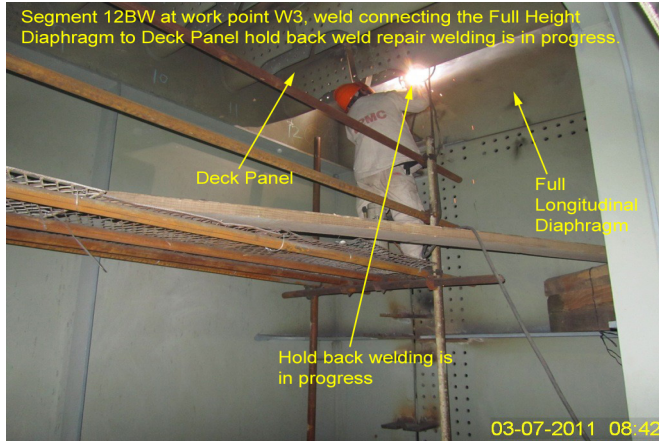
This Quality Assurance (QA) Inspector witnessed final bolt tension verification for Lower Chevron, Upper Chevron and H-Beam connecting the floor beam and splice plate at Panel Points (PP) 109, PP 110, PP111 and PP 112 for Segment 12AE at Bike Path side and Cross Beam side. Inspected 10% on a random basis and found the tension to be in general compliance. Inspection was performed against the Notification No. 00622 Dated March 07, 2011.

This Quality Assurance (QA) Inspector witnessed final bolt tension verification for Lower Chevron, Upper Chevron, X3D Bracket connected to floor beam flange and to the splice plate and H-Beam connecting the floor beam and splice plate at Panel Points (PP) 113 and PP 114 for Segment 12BW at Counter Weight and Cross Beam side. Inspected 10% on a random basis and found the tension to be in general compliance. Inspection was performed against the Notification No. 00621 Dated March 07, 2011.

This Quality Assurance (QA) Inspector witnessed final bolt tension verification for Lower Chevron, Upper Chevron, X3D Bracket connected to floor beam flange and to the splice plate and H-Beam connecting the floor beam and splice plate at Panel Point (PP) 115 for Segment 12CW at Counter Weight and Cross Beam side. Inspected 10% on a random basis and found the tension to be in general compliance. Inspection was performed against the Notification No. 00621 Dated March 07, 2011.

Complete Joint Penetration (CJP) groove weld. The Weld joint was designated as DP3056-001-021. The welder identification was 046709 and was observed welding in the 4G (Overhead) position using approved Welding Procedure Specification WPS-B-P-2214-Tc-U4b-FCM-1. The piece mark was identified as full height Longitudinal Diaphragm web to Deck Panel hold back weld at work point W3.

This QA Inspector observed the in-process welding by Shielded Metal Arc Welding (SMAW) process on a Complete Joint Penetration (CJP) groove weld. The Weld joint was designated as DP3067-001-009. The welder identification was 046709 and was observed welding in the 4G (Overhead) position using approved Welding Procedure Specification WPS-B-P-2214-Tc-U4b-FCM-1. The piece mark was identified as full height Longitudinal Diaphragm web to Deck Panel hold back weld at work point W3.
